## **CORROSION CONSIDERATIONS FOR ABOVEGROUND ATMOSPHERE STORAGE TANKS**

**Vincent A. Carucci  
John F. Delahunt  
Carmagen Engineering, Inc.  
4 West Main Street  
Rockaway, New Jersey 07866**

### **ABSTRACT**

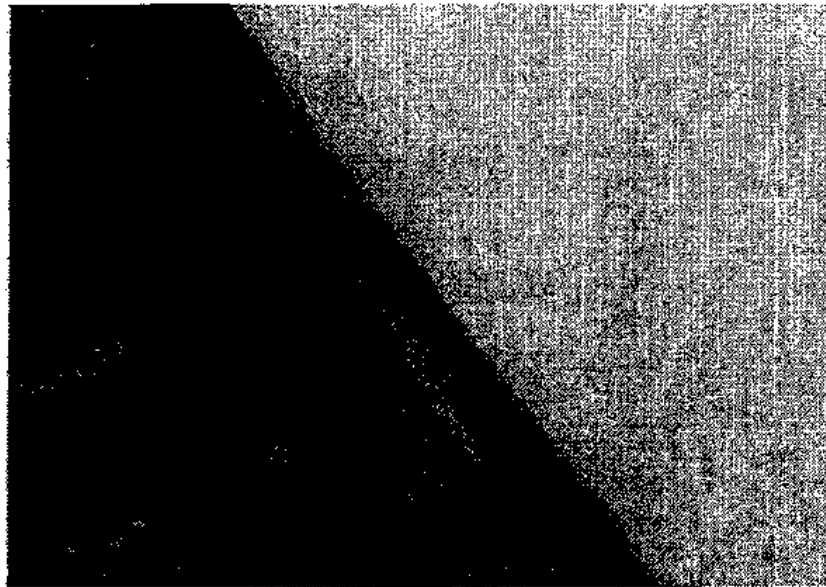
The dilemma here is that corrosion occurring on the underside of the tank bottom resting on a concrete or crushed stone ring wall will probably not be identical to that occurring over the rest of the tank bottom. It is accepted that a cathodic protection system will not be effective at the juncture of the shell/bottom plate because of the concrete ring wall. Also, it is at times reported that CP is not effective on the bottom plate adjacent to the concrete wall because of voids often found along the inside of the concrete wall. Severe corrosion can also occur in this area where a crushed stone ringwall is used. Mounding around the perimeter of the tank may result because of tank settlement which will trap rain water. This is shown in Figure 4 and discussed below.

Rainwater that runs down the tank shell will find its way beneath the tank shell and will cause corrosion in the "critical zone" no matter which ring wall is used. This is of major concern because inspection in this area is usually not possible until the tank is emptied and out-of-service. However, the underside corrosion near the bottom/shell juncture can be difficult to detect and measure even with the tank out-of-service and opened for inspection, so special precautions are often made.

Tank settlement has caused mounding around the storage tank perimeter and corrosion around the perimeter of the tank has taken place.

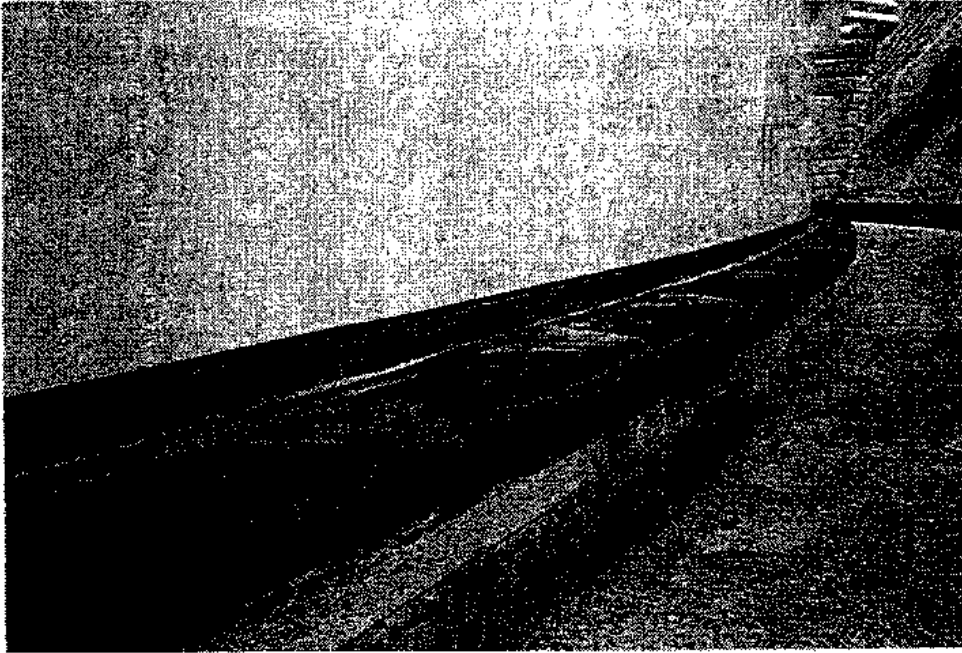
Figure 5

A hot applied bituminous roof felt was applied to the perimeter of the tank and across and down the concrete ringwall to prevent rainwater migration beneath the tank bottom.

To minimize such underside corrosion, some owners provide positive rain shelters and others provide sloped mastic or bituminous-impregnated hot applied tapes in order to externally seal the juncture of shell/bottom plate to prevent rainwater migration. See Figure 5. In API Standard 650, as an option, an asphalt-impregnated board is shown placed under the perimeter during tank construction.

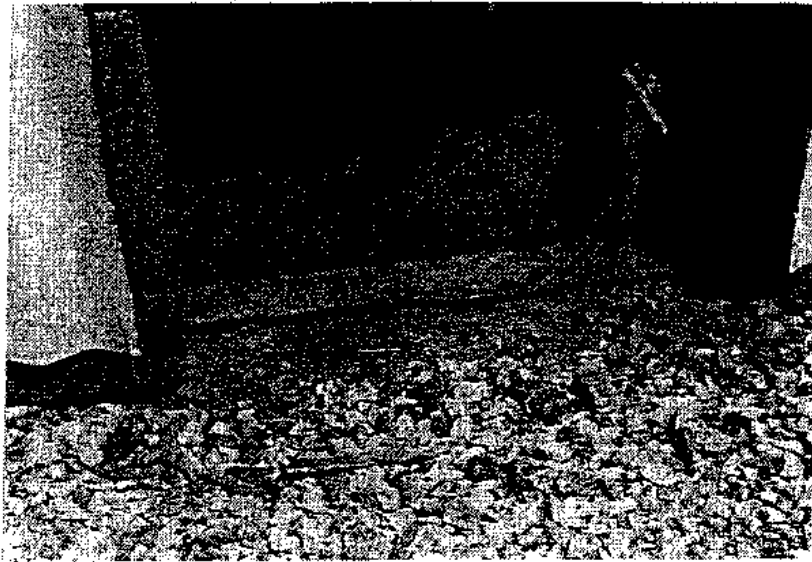
Figure 6

The third concern is severe corrosion of the portion of the tank bottom that extends outside of the tank shell which is shown in Figure 6. API Standard 653 states that this extension cannot be less than 2.5 mm (0.10 in.) thick and the remaining projection of the bottom plate, measured at the toe of the outside bottom-to-shell fillet weld, shall be at least 9.5 mm (0.375 in.) thick. The original length of this protection is one inch minimum for sketch plates and two inches for annular plates. There are several causes for corrosion of this extension. These include: rainwater running down the side of the tank and finding its way under the tank, mounding around the tank, and corrosion under the shell thermal insulation system extends to the bottom of the tank so that this section of the tank cannot be inspected.

Corrosion of the bottom plate extension is shown in this photograph. This occurred on a thermally insulated tank that employed cellular glass block. Cellular glass has been used unsuccessfully in the past to prevent such corrosion. The insulation system should be terminated 12 in. above the tank bottom and this area properly coated.

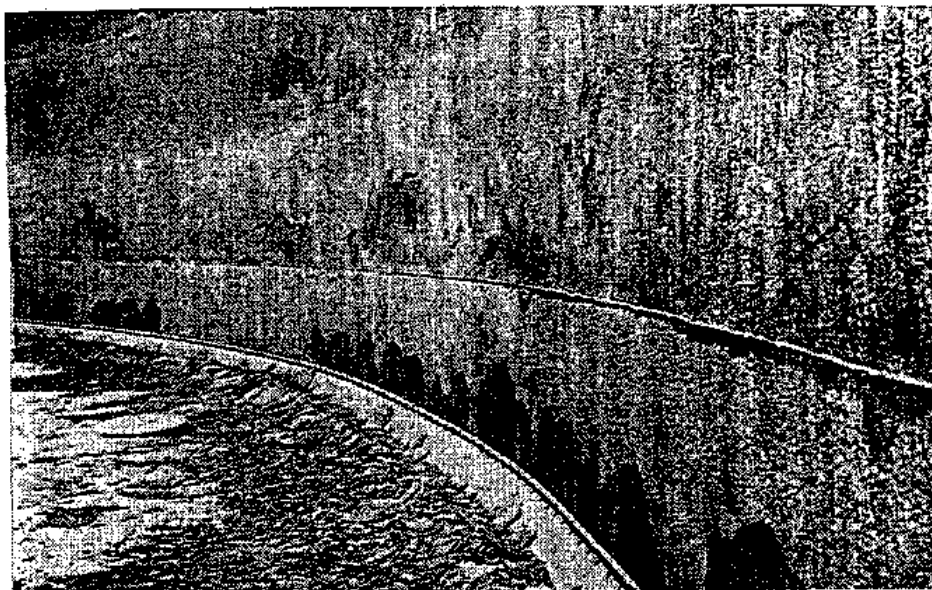
Figure 7

Photograph illustrating internal shell corrosion of an external floating roof storage tank in light product service. Linings are frequently applied to prevent internal shell corrosion and/or protect product quality.
