**IPEIA 2009
COKER DRUM CRACKING**

**13TH Annual IPEIA Conference
Banff Centre, Banff, AB
11 - 13 February 2009**

DELAYED COKER DRUM CRACKING

**J Aumuller, P. Eng.
Edmonton, AB Canada**

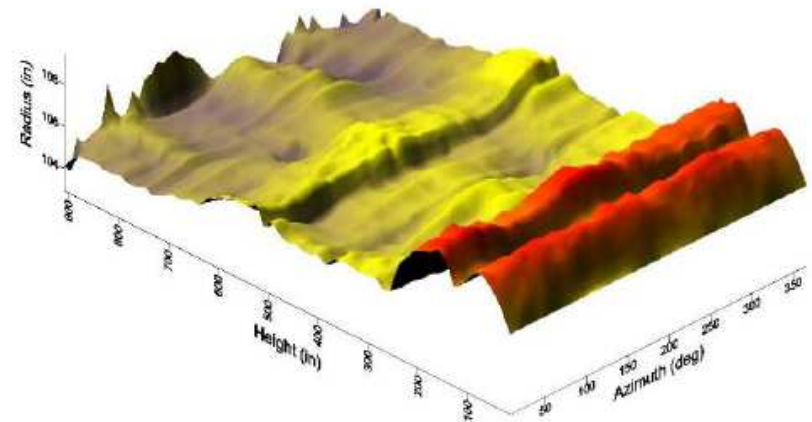
- actual bulge behavior

Courtesy of CIA Inspection, Hannon ON & Stress Engineering, Houston TX

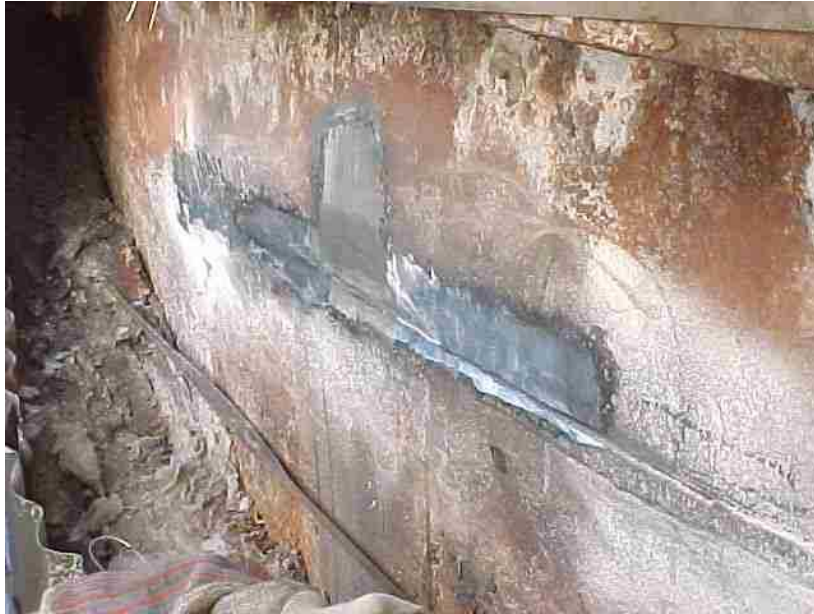
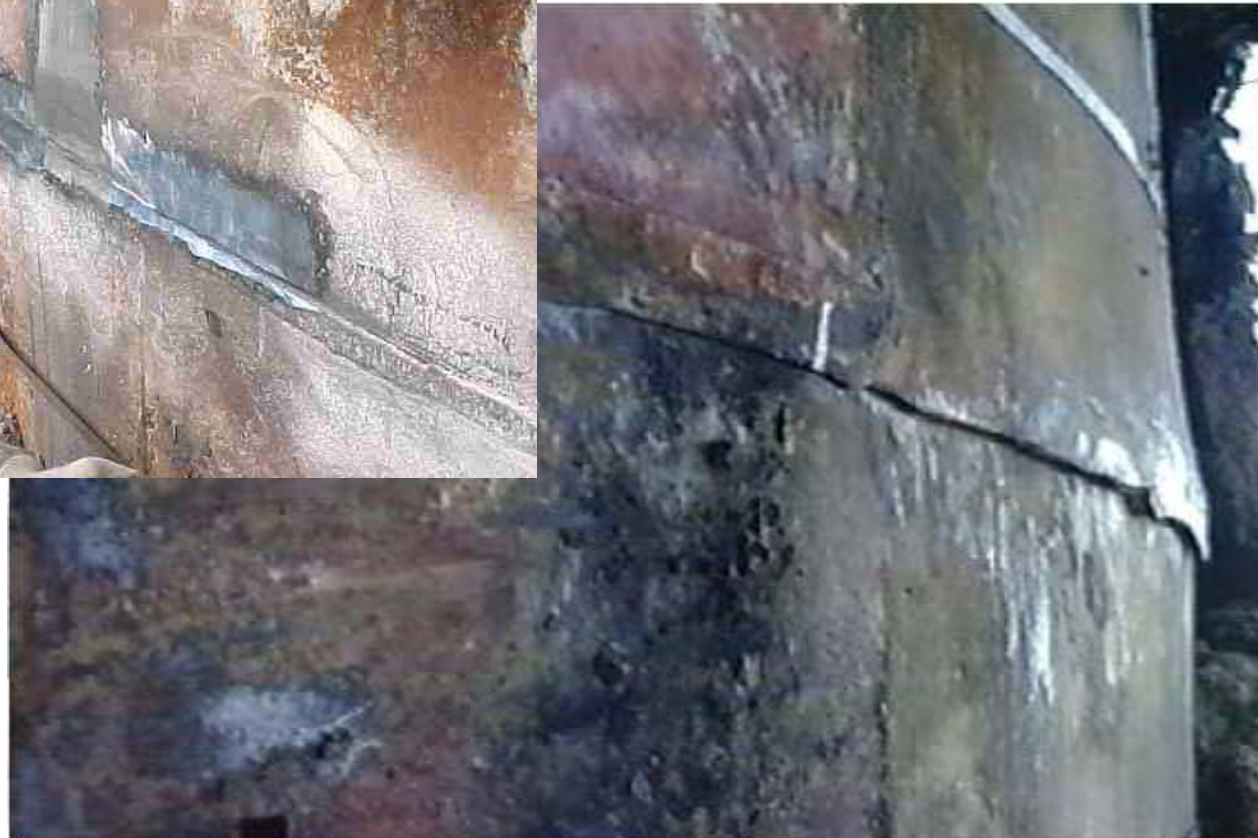
- cracking associated with circumferential welds

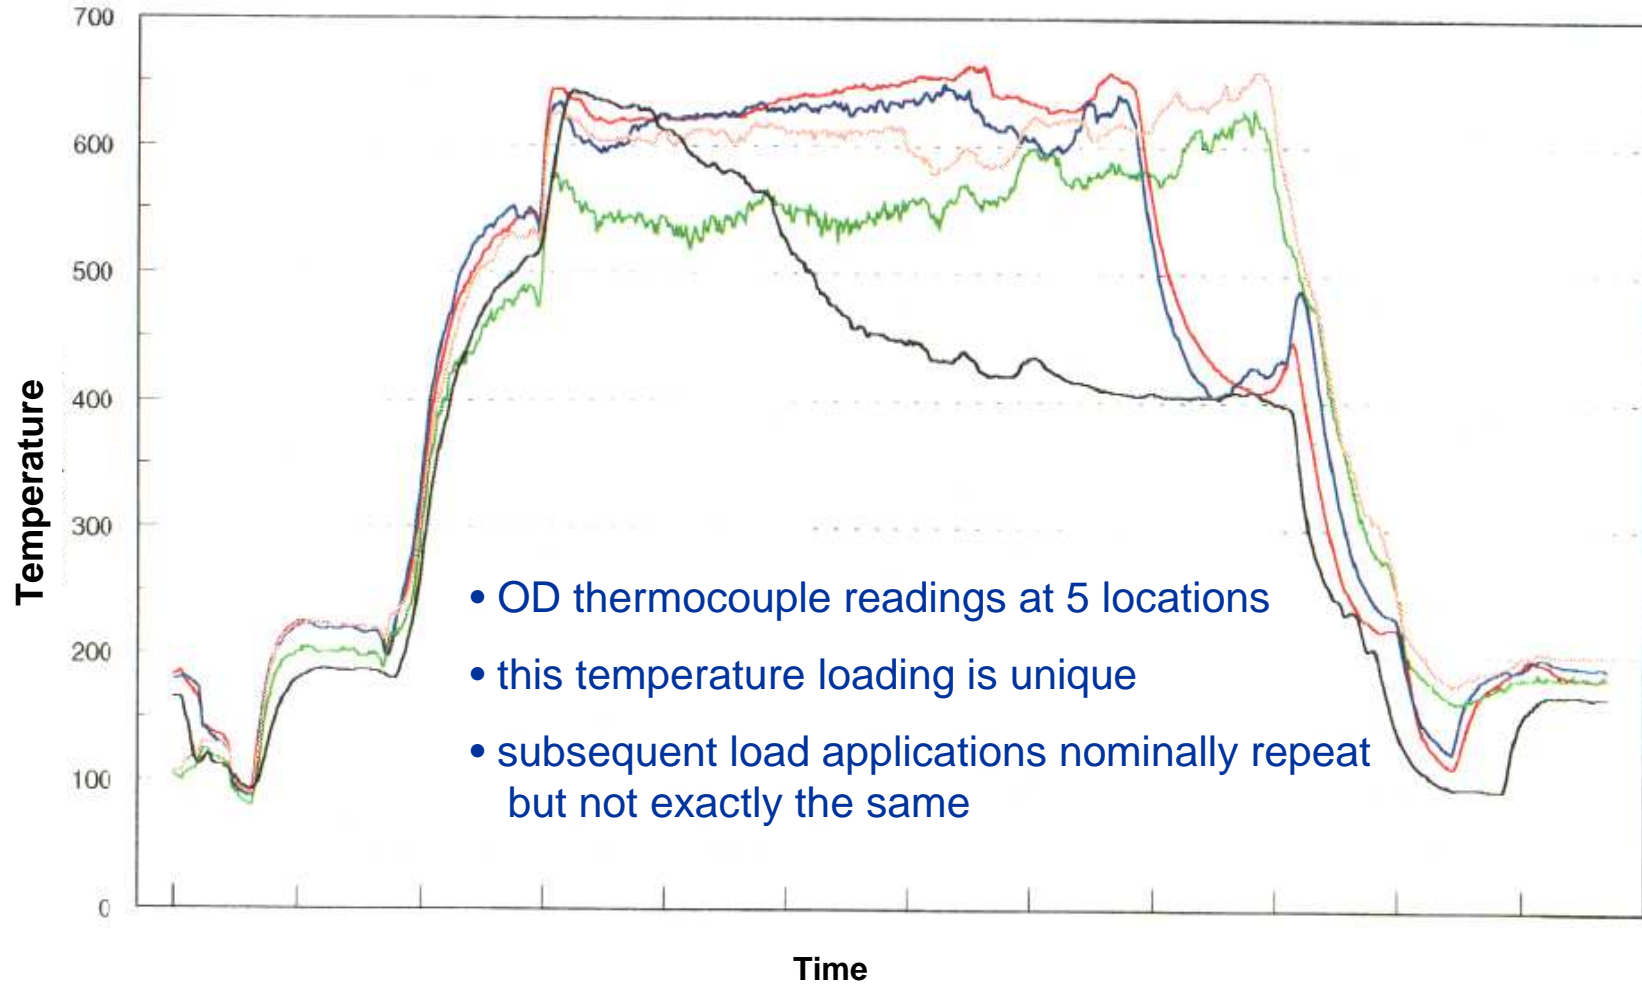
- Temperature loading

- temperature cycling
 - steam test
 - vapor heat
 - oil in
 - steam quench
 - water quench
- pressure cycling
 - pressure rise at start of cycle, nominally constant through cycle, pressure decline to atmospheric at end of cycle
- live weight cycling
- deadweight

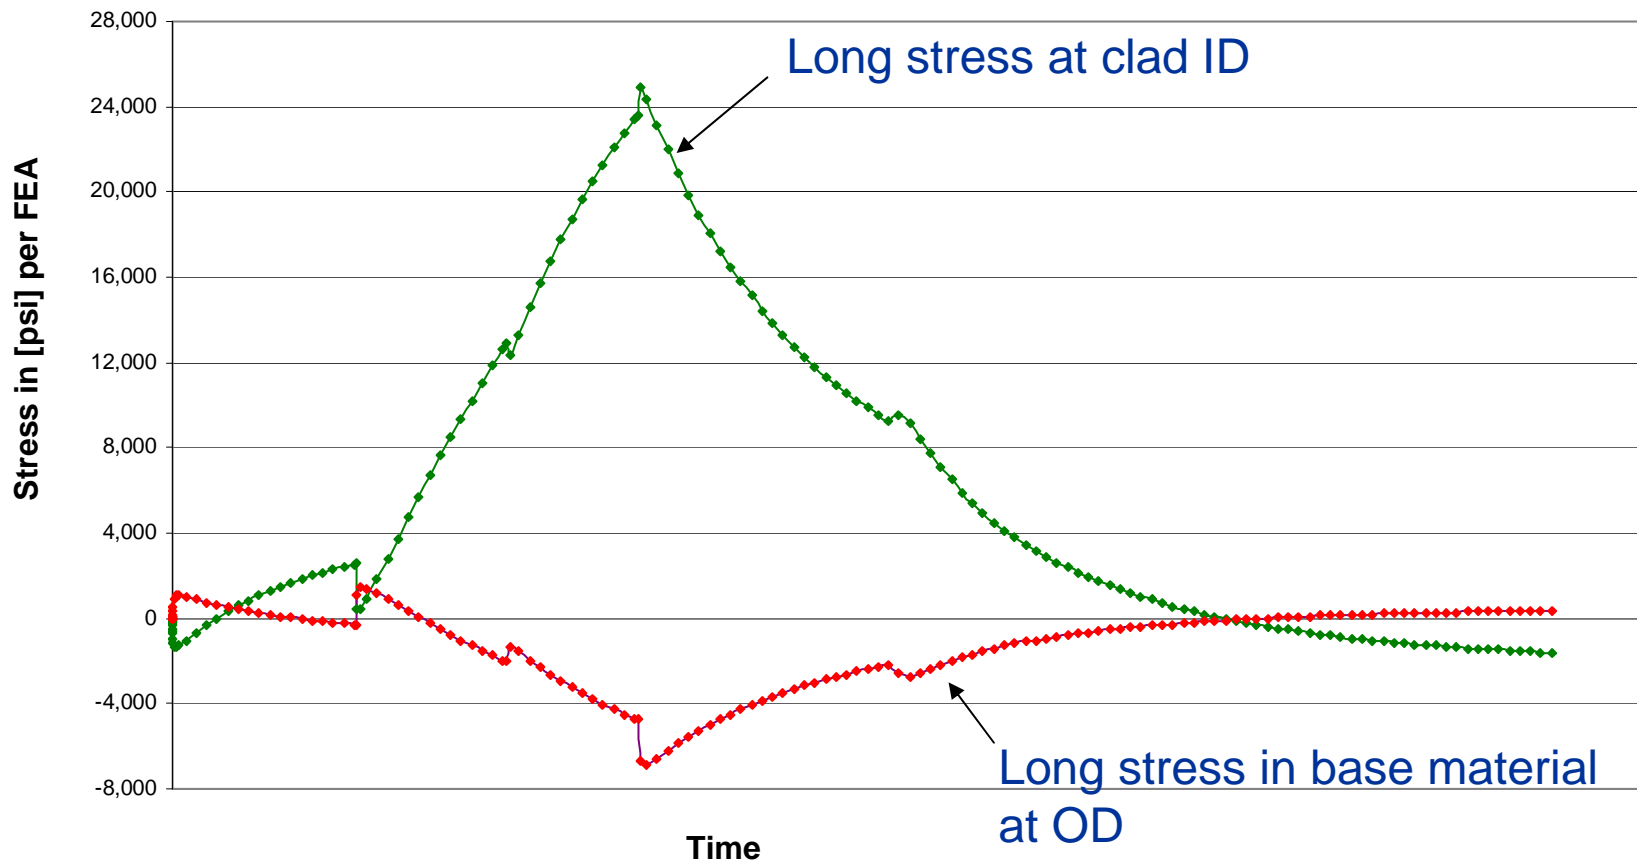
- Longitudinal stress at shell ID and OD due to temperature
 - industry assumption is that clad ID is in compressive loading!

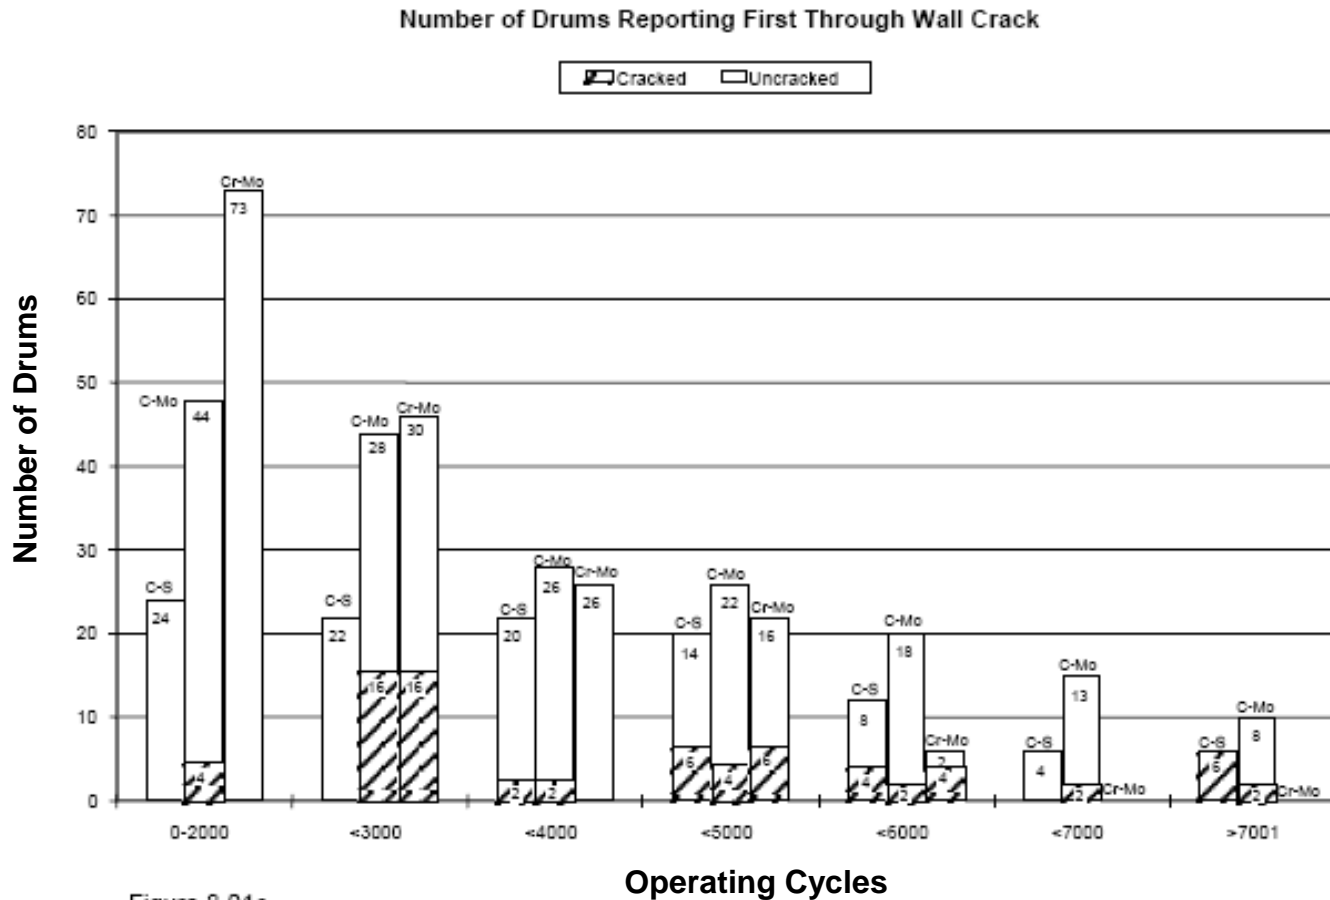
Figure 8.01c

- API Coke Drum Survey – First Thru Wall Cracks

Source: API Proceedings, 1996 API Coke Drum Survey – Final Report

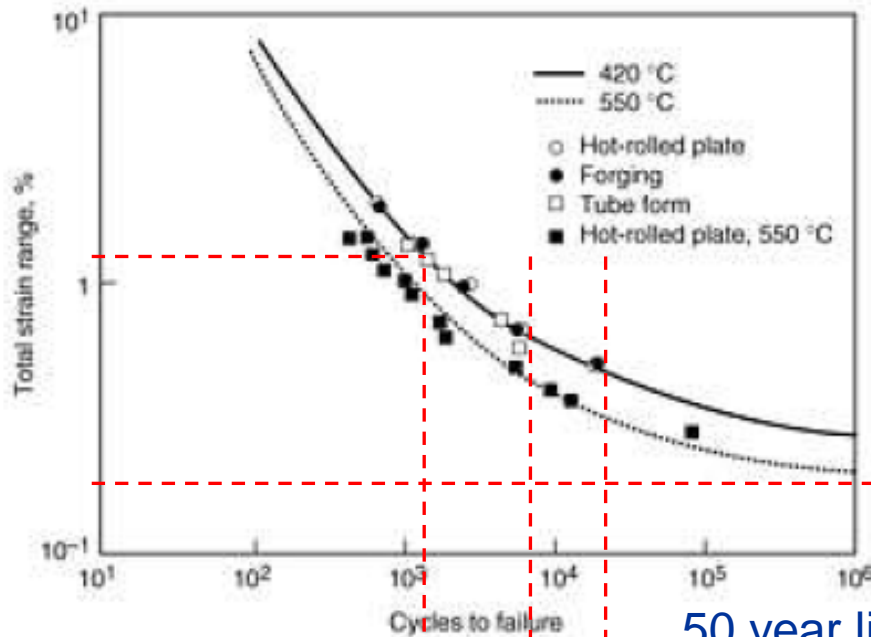
- Reconciling theory with experience

impact of notch

50 year life

25 year life

$$\Delta\epsilon_{\text{clad}} \sim 0.1\%$$

$$\Delta\epsilon_{\text{base}} < 0.1\%$$

- Reconciling theory with experience
 - failure experience
 - SEM measured cracking rates of $2.7 \cdot 10^{-4}$ to $2.3 \cdot 10^{-3}$ mm/cycle
 - cleavage fracture occurs through majority of crack surface !
 - fast crack growth once ID surface crack manifests
 - evaluation
 - calculated crack rate of $9.84 \cdot 10^{-4}$ mm/cycle in earlier slide
 - once crack propagates through clad, $K \approx 18.6 \text{ MPa}\sqrt{\text{m}}$
 - SCC / HE enabled $\rightarrow \frac{da}{dt} = 1 \cdot 10^{-8} \Rightarrow 1 \cdot 10^{-5} \text{ m/sec}$
 - $t = 29$ days to < 1 hour ! \rightarrow coincides with observation
