LININGS FOR ABOVEGROUND STORAGE TANKS

J.F. Delahunt
Carmagen Engineering, Inc.
7 Waverly Place
Madison, New Jersey

ABSTRACT

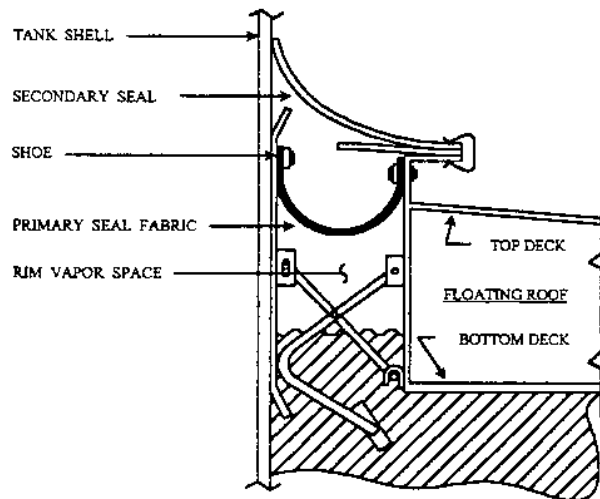
A schematic drawing of one type of seal used on floating roof tanks. As the seal moves with the roof, it will remove rust scale and exposes "fresh" metal to atmospheric corrosion.

Figure 2 shows a common seal design used for both FRT and IFRT tanks. These seals provide product conservation by minimizing evaporative product or light blending component losses. It consists of a metal shoe that rides against the shell of the tank. There is both a primary and secondary seal - the first is frequently an elastomeric fabric seal and a secondary elastomeric seal. Both can be changed out because of abrasive wear and deterioration during working of the tank.

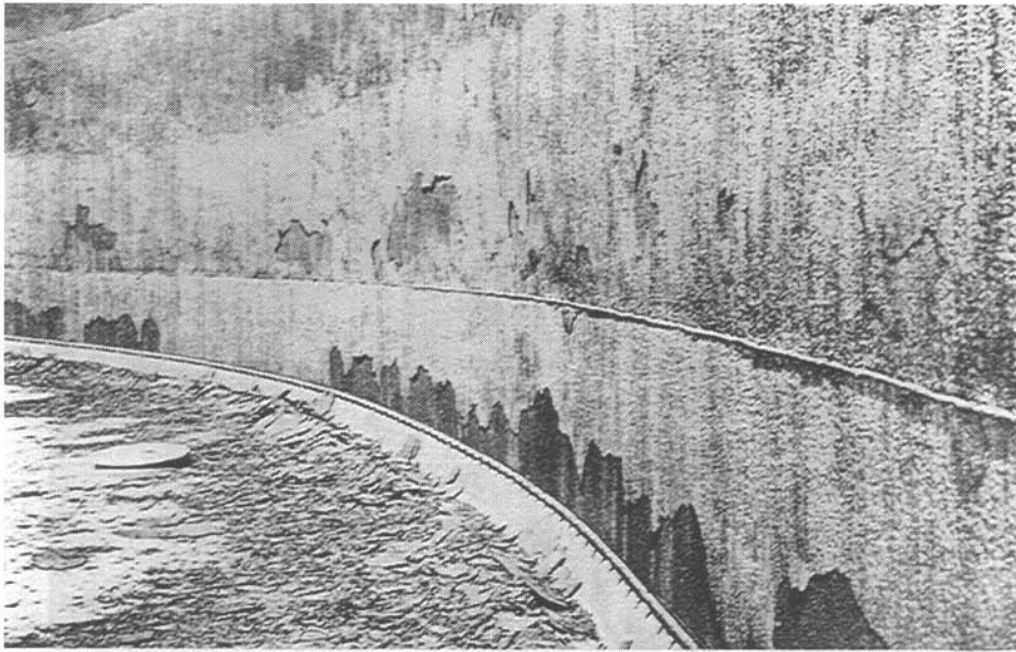
Figure 3

Photograph of severe corrosion and heavy rust scale of the internal shell of a floating roof tank four years after construction.

The interior shell of a EFRT tank encounters corrosion much more severe than encountered by a carbon steel structure exposed in the same environment. The accelerated corrosion is caused by the floating roof moving up and down as the tank works and the steel shoe and the roof seals moved against the shell.⁽²⁾ This movement abrades and removes the existing rust or scale to some extent exposing “fresh” metal. Any light product such as gasoline or blending components evaporates quickly and atmospheric corrosion takes place. See Figure 3, which shows aggravated internal corrosion of the tank shell.

After evaluating coefficients of friction, it was concluded that roof seal wear would be considerably greater in a FRT where the shell had been corroded and rust scale is present. See Figure 3. The coefficient of friction may be much larger for a corroded surface than a coated steel surface. It was estimated that depending upon the environmental location and working of the tank, seal life might be considerably extended if the shell is coated.

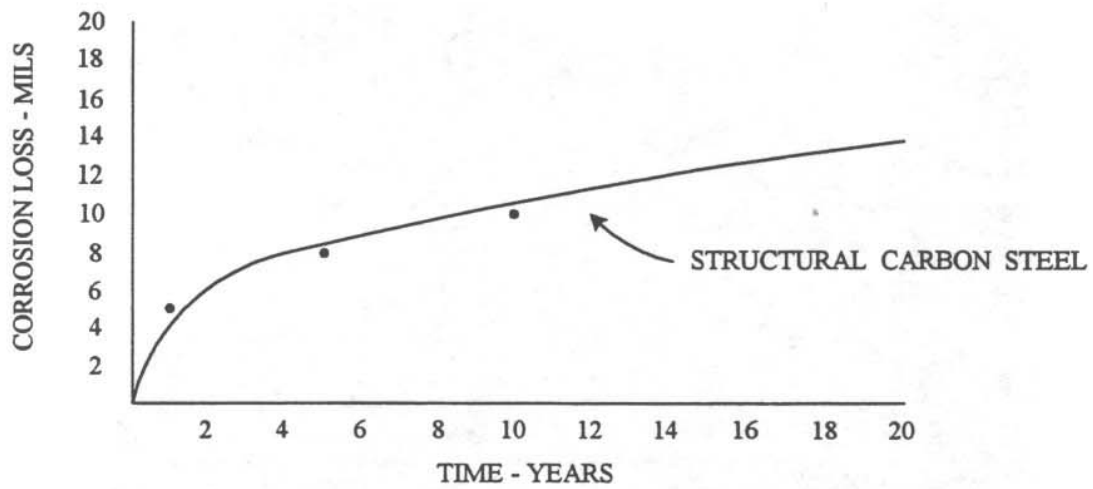
Figure 4

The atmospheric corrosion curve of carbon steel when exposed in a severe Northeastern industrial environment.

In an industrial location, such as N.E., an atmospheric corrosion curve shows a maximum rate of 4-5 mils per year in the first year, but after that the corrosion rate decreases rapidly to such an extent that total metal loss after 20 years is only 12-13 mils.⁽⁵⁾ This is a result of an oxide scale forming and to some extent, preventing the access of water and oxygen. See Figure 4. As discussed above, that does not occur in EFRT and a continuing high corrosion rate is encountered.
