LININGS FOR ABOVEGROUND STORAGE TANKS

J.F. Delahunt
Carmagen Engineering, Inc.
7 Waverly Place
Madison, New Jersey

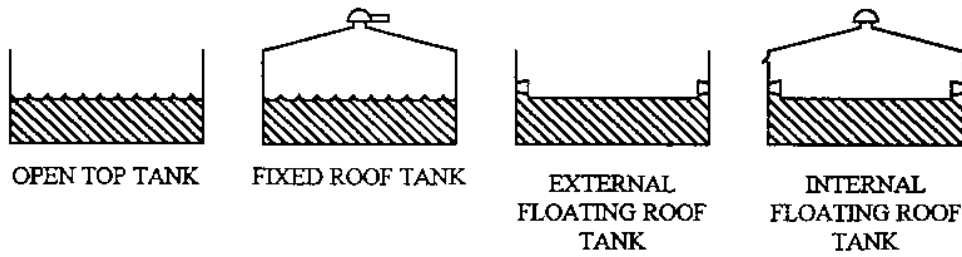
Figure 1

As shown schematically, is the construction of various types of aboveground storage tank construction. Open top tanks are no longer in use.

There are three primary designs of AGST in use today; they are Fixed Roof Tanks (FRT), which are frequently addressed as cone roof tanks, External Floating Roof Tanks (EFRT) and the newer Internal Floating Roof Tanks (IFRT).⁽⁴⁾ Open top tanks or reservoirs were used up until the 1950's but are no longer in use today. Primarily, this paper will be concerned with linings for EFRT and FRT tanks since much of the industry experience is concerned with these two types. The construction of the various AGST is describe below and schematically shown in Figure 1.

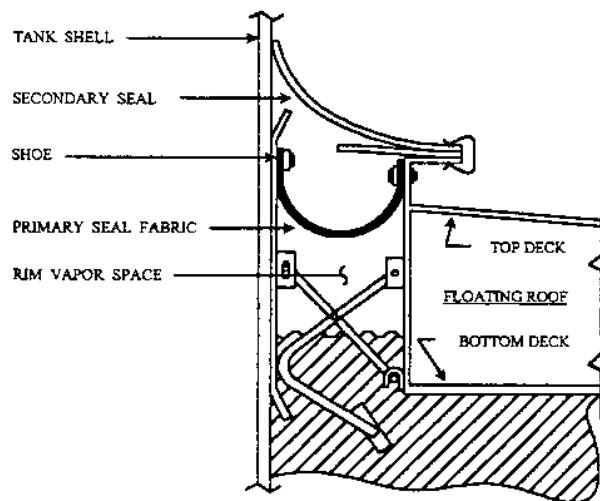
A schematic drawing of one type of seal used on floating roof tanks. As the seal moves with the roof, it will remove rust scale and exposes "fresh" metal to atmospheric corrosion.

Figure 2 shows a common seal design used for both FRT and IFRT tanks. These seals provide product conservation by minimizing evaporative product or light blending component losses. It consists of a metal shoe that rides against the shell of the tank. There is both a primary and secondary seal - the first is frequently an elastomeric fabric seal and a secondary elastomeric seal. Both can be changed out because of abrasive wear and deterioration during working of the tank.

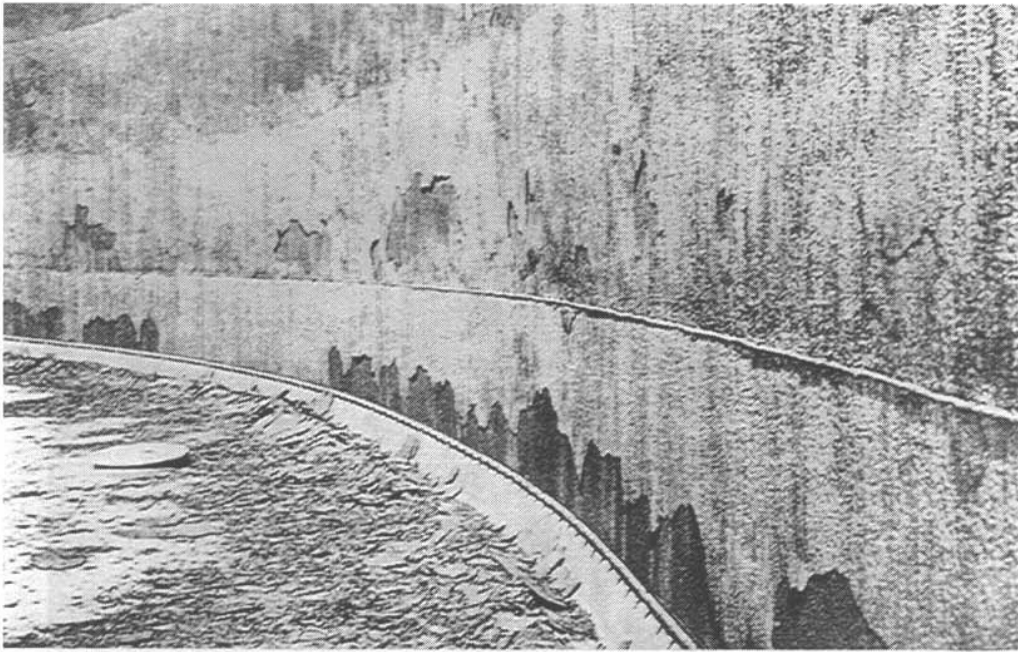
Figure 3

Photograph of severe corrosion and heavy rust scale of the internal shell of a floating roof tank four years after construction.

The interior shell of a EFRT tank encounters corrosion much more severe than encountered by a carbon steel structure exposed in the same environment. The accelerated corrosion is caused by the floating roof moving up and down as the tank works and the steel shoe and the roof seals moved against the shell.⁽²⁾ This movement abrades and removes the existing rust or scale to some extent exposing "fresh" metal. Any light product such as gasoline or blending components evaporates quickly and atmospheric corrosion takes place. See Figure 3, which shows aggravated internal corrosion of the tank shell.

After evaluating coefficients of friction, it was concluded that roof seal wear would be considerably greater in a FRT where the shell had been corroded and rust scale is present. See Figure 3. The coefficient of friction may be much larger for a corroded surface than a coated steel surface. It was estimated that depending upon the environmental location and working of the tank, seal life might be considerably extended if the shell is coated.

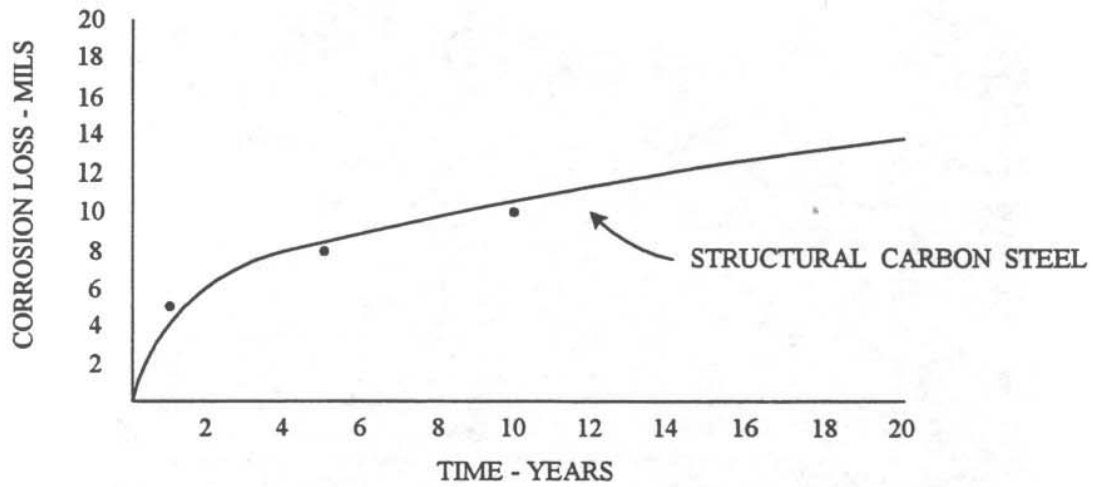
Figure 4

The atmospheric corrosion curve of carbon steel when exposed in a severe Northeastern industrial environment.

In an industrial location, such as N.E., an atmospheric corrosion curve shows a maximum rate of 4-5 mils per year in the first year, but after that the corrosion rate decreases rapidly to such an extent that total metal loss after 20 years is only 12-13 mils.⁽⁵⁾ This is a result of an oxide scale forming and to some extent, preventing the access of water and oxygen. See Figure 4. As discussed above, that does not occur in EFRT and a continuing high corrosion rate is encountered.

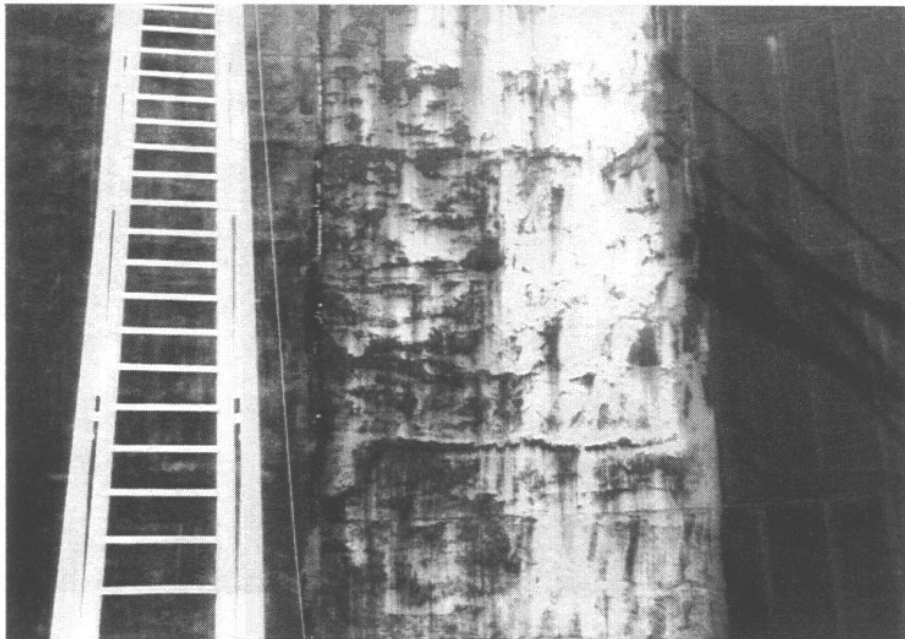
Figure 5

A photograph of the interior shell showing the condition of the protective coatings applied approximately 34 years ago. The phenolic coating system is shown in the center of the photograph and on either side is the vinyl system.

Figures 5 and 6 show these systems in 1985. The Amercoat vinyl was in the best condition and the Socony 11-A-6 is still offering some protection. The terminal operator reported that about 35 years after application brush and roller marks were still visible.

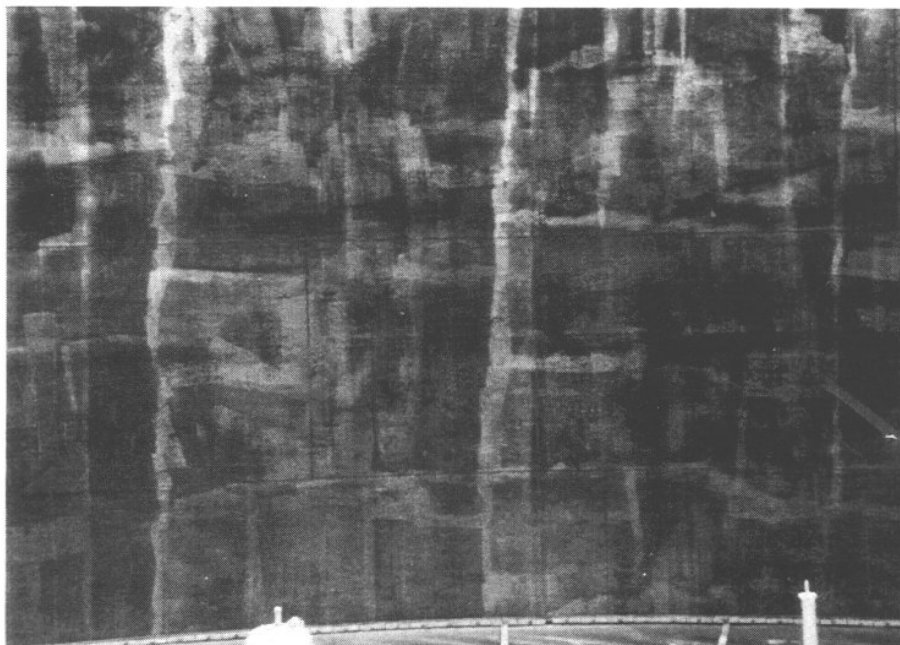
Figure 6

Another view of the vinyl system showing its protective value and also, the roller application marks.

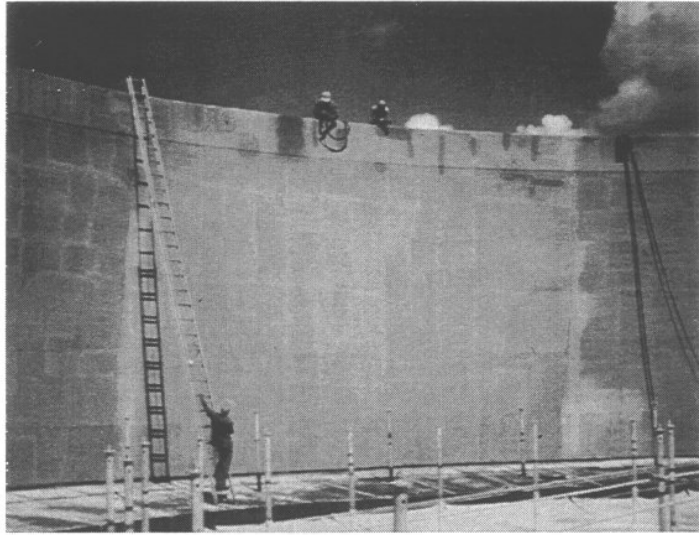
The shell of a floating roof tank after application of a postcured water based inorganic zinc rich coating.

These were evaluated after a six month period of exposure and it was determined that all the epoxies and epoxy co-polymers were chalking badly. There was general creep corrosion occurring for all organic linings at high points of the shell where there was shoe abrasion and several showed indications of pinpoint rusting. The water based IZRC showed none of these problems and it was recommended for general application in EFRT tanks with an estimated life of 10+ years. Figure 7 shows an IZRC application to the shell of an EFRT in the 1960's.

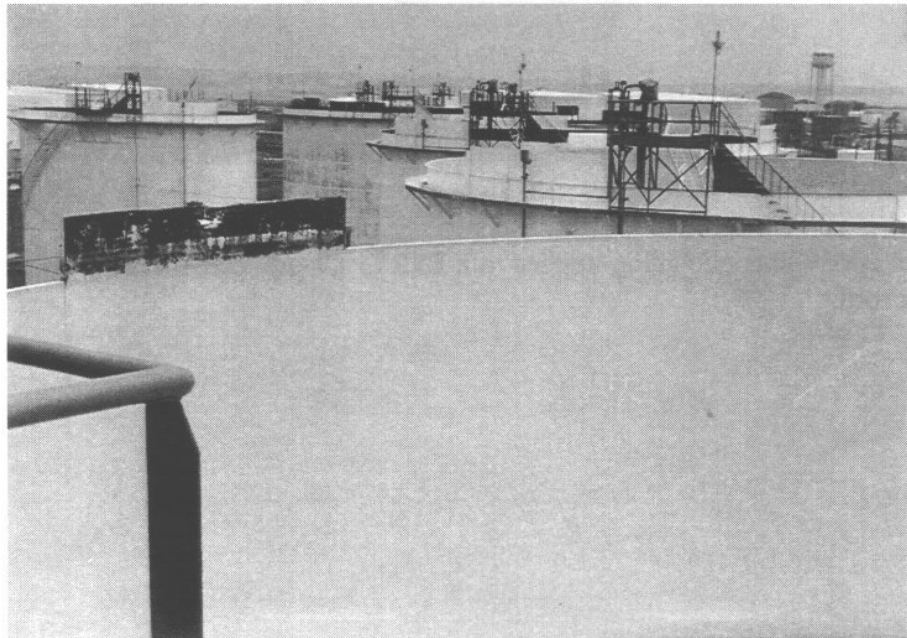
Figure 8

The shell of a floating roof tank in jet fuel service coated with an epoxy-phenolic. Note the extent of corrosion on the baffle for the foam fire fighting system. Additional lined tanks are shown in the background.

- Jet Fuel - Linings for jet fuel storage are generally selected from qualified purchasing lists for U.S. Military specifications or British Military specifications. IZRC should not be used because of possible product quality problems. Figures 8 and 9 shows epoxy-phenolic linings applied to the shells of EFRT in jet fuel service; abrasion by the roof seal is clearly evident.

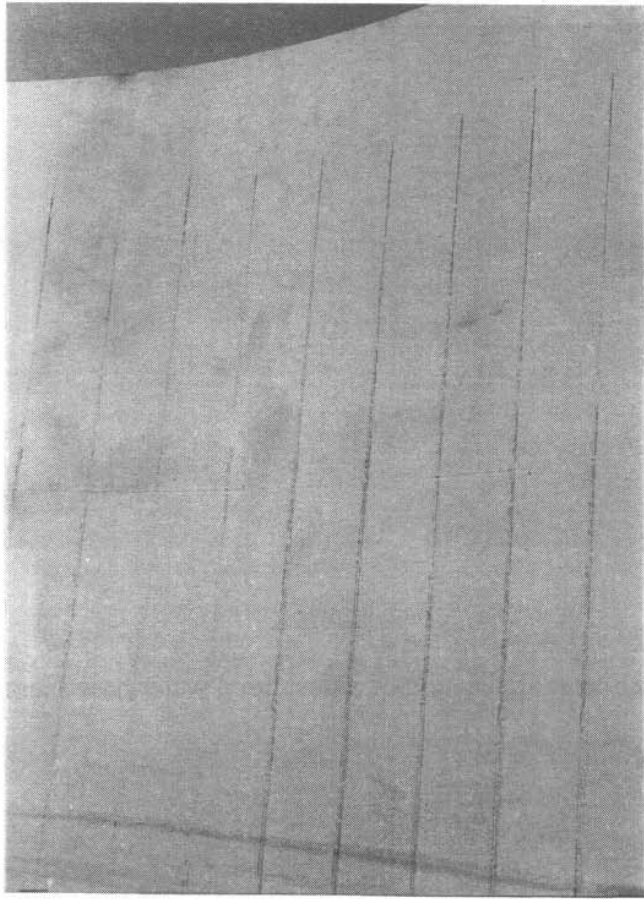
Figure 9

Another view of an epoxy-phenolic lining applied to a EFRT. Clearly evident is the abrasion caused by the seal of the floating roof.
