The **CARMAGEN** Report[®] ENGINEERING INC.

OCTOBER 2004

Common Causes of Flange Leakage

Common Causes of Piping Vibration

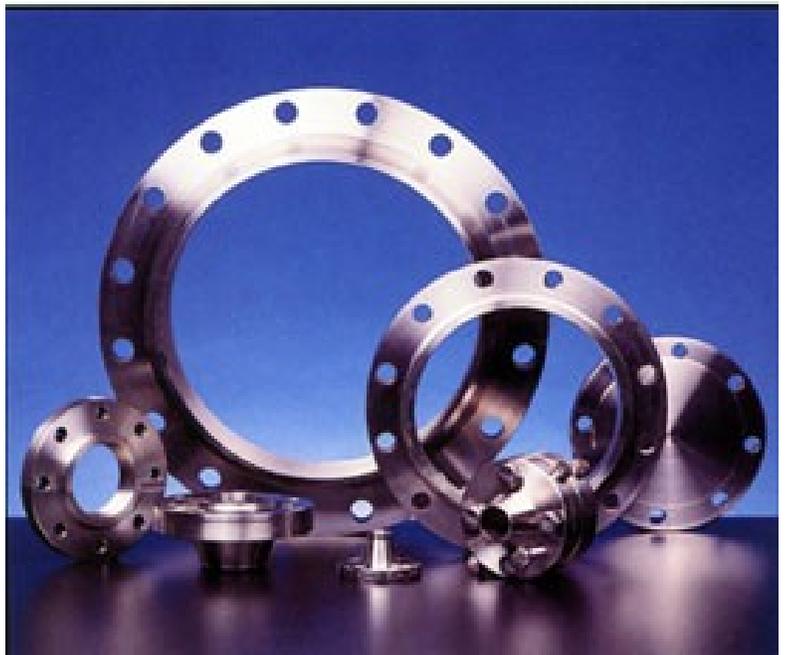
- ❖ **Improper Gasket Centering.** If a gasket is installed off center compared to the flange faces, the gasket will be unevenly compressed and make the joint prone to leakage. Spiral wound and double jacketed gaskets usually have a centering ring that extends to the inner edge of the bolts. A sheet gasket can be cut so that its outside diameter matches the inner edge of the bolts.

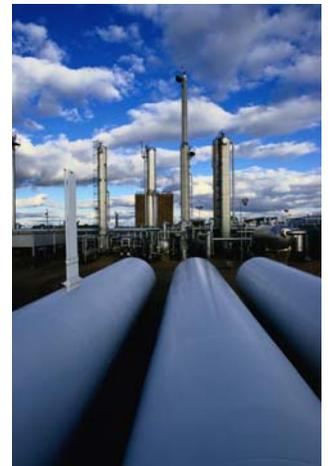
Wind can cause piping vibration by vortex shedding from the pipe surface. If wind strikes at a right angle to the axis of a cylinder, aerodynamic forces due to vortex shedding occur at the following frequency that is a function of wind velocity, cylinder diameter, and Strouhal number (0.18 for cylinders in air).

These forces act on the pipe at right angles to the wind direction. Although the forces are small, the amplitude of vibration may be large if the shedding frequency is close to the natural frequency of the piping.

If a problem exists, the stiffness and the natural frequency of the piping should be increased by adding bracing, consistent with still meeting piping flexibility and associated equipment requirements. Mechanical snubbers and shock absorbers may also be used to change the stiffness and add damping to the piping system while still permitting its thermal movement.
